Manhole Inspection Summary

Manhole # S29C__126MH

Location Address: **708 murphy ln**

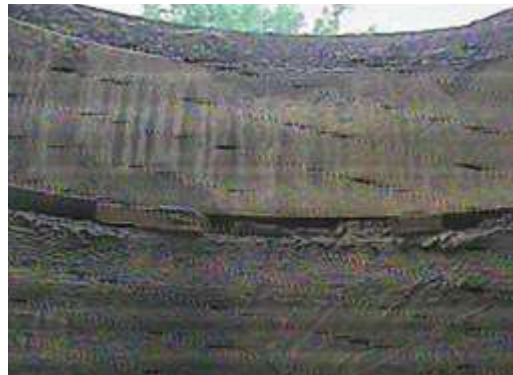
Defect 1

Condition: ☐ Sound ☐ Cracked ☐ Root Intrusion ☒ **Loose Brick** ☐ Deteriorated

LOOSE BRICKS at chimney

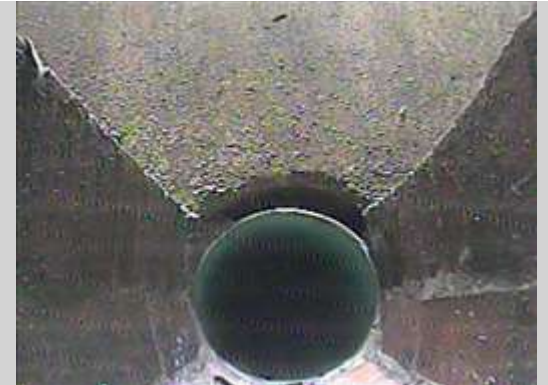
12 O'Clock Outflow

8 in. Circular Gravity Sewer
Pipe Out @ 12 O'Clock

Pipe Height: (in.) Direct
Pipe Material: **PVC** ☐ Pipe Lined
Invert Depth: **10.72** (ft.) Flow Characteristics: **Slow**
Deposits: ☒ None ☐ Mud ☐ Sludge ☐ Debris ☐ Grease
Silt Depth: (in.) Deposits Extent:
Infiltration: **None** Pipe Seal Cond: **Sound**

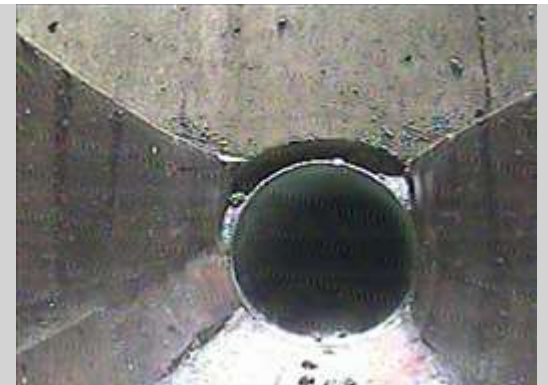
6 O'Clock Inflow

8 in. Circular Gravity Sewer
Pipe In @ 6 O'Clock

Pipe Height: (in.) Direct
Pipe Material: **PVC** ☐ Pipe Lined
Invert Depth: **10.65** (ft.) Flow Characteristics: **Slow**
Deposits: ☒ None ☐ Mud ☐ Sludge ☐ Debris ☐ Grease
Silt Depth: (in.) Deposits Extent:
Infiltration: **None** Pipe Seal Cond: **Sound**
